Minerals Inspection Report

Mine Name: Black Butte	Permit Number: S/015/0080	Mine Status: Active
Operator Name: Goldterra Inc.	Inspection Date: 10/30/2014	Permit Fees: Paid
Inspector(s): Wayne Western	Inspection Time: 12:10 - 12:40 pm	Bond Amount: \$7,600
Attendee(s): Dan Guy	Weather: cool and fair skies	Bond Escalation: 03/26/2014
Inspection Purpose: Operator request		Prior Inspection: 09/25/2014

S/015/080, Black Butte Mine, GoldTerra

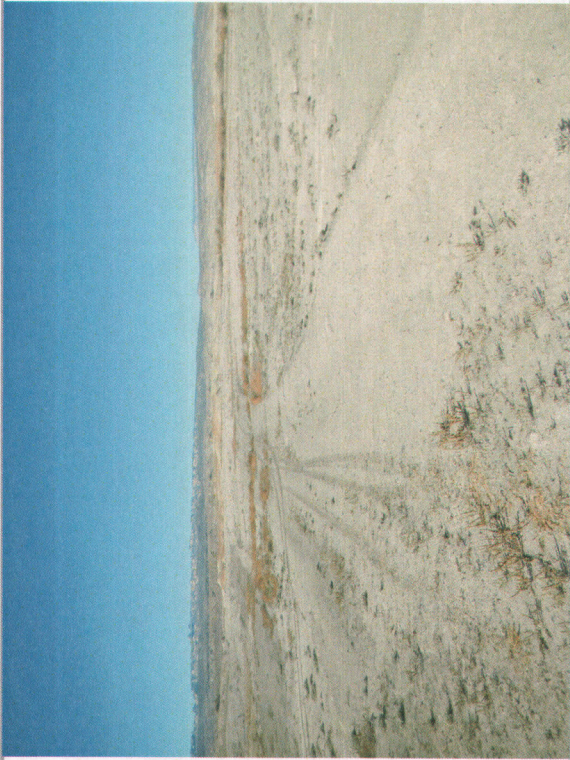
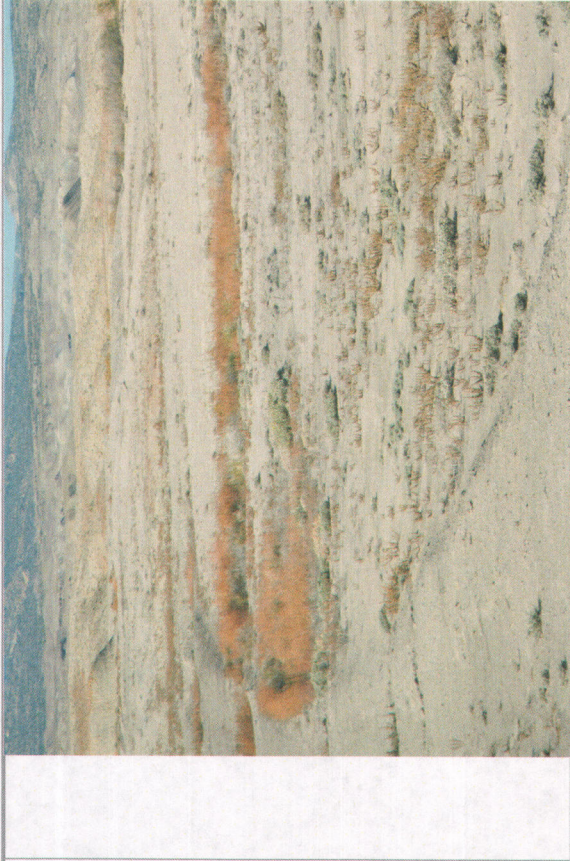
<p>Notice rock formation. This is an identify feature that is easy to use to located site. There are several pieces of rebar on site that were used as</p>
 	 	<p>Mine area was not developed. A sampling project might have occurred.</p>
 	 	<p>Mine area notice rebar</p>
 	 	<p>Undisturbed area not lack of vegetation</p>

There was an area which was staked with re-bar on a grid. Reclamation of the grid are should be done by removing the re-bar.

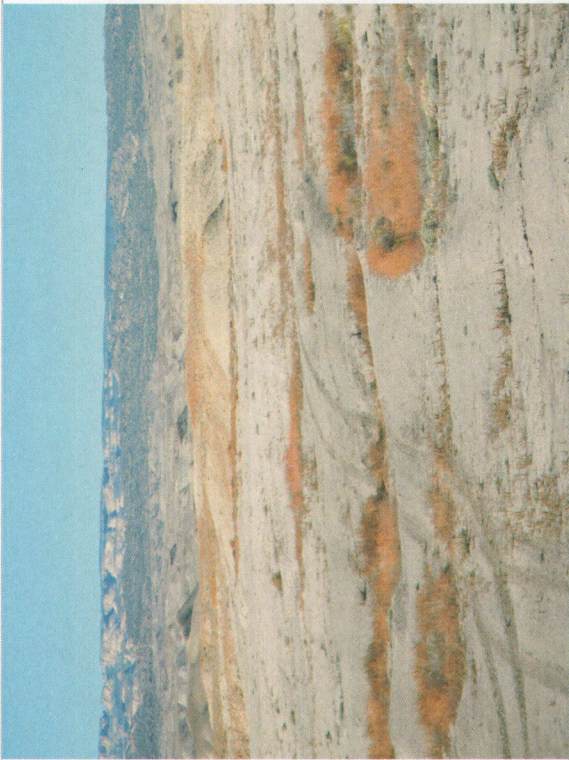
Main access road to site Vegetation is limited along the road

The access road to the site needs to be reclaimed. To the west of the site is a check dam that was constructed by the CCC in the 1930. The road to the check dam was preexisting and will not be reclaimed. The road to the east of the check dam was constructed as part of the mine and will be reclaimed.

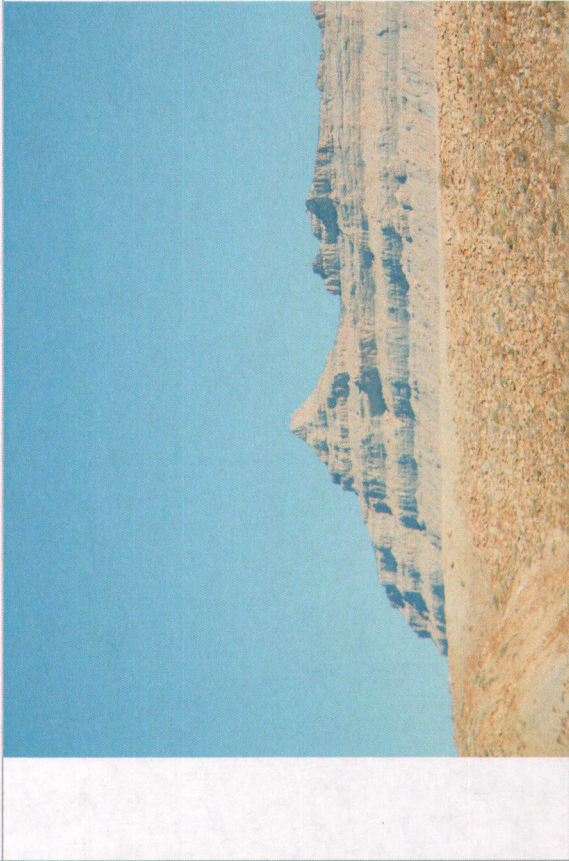
Main access road Surrounding area.

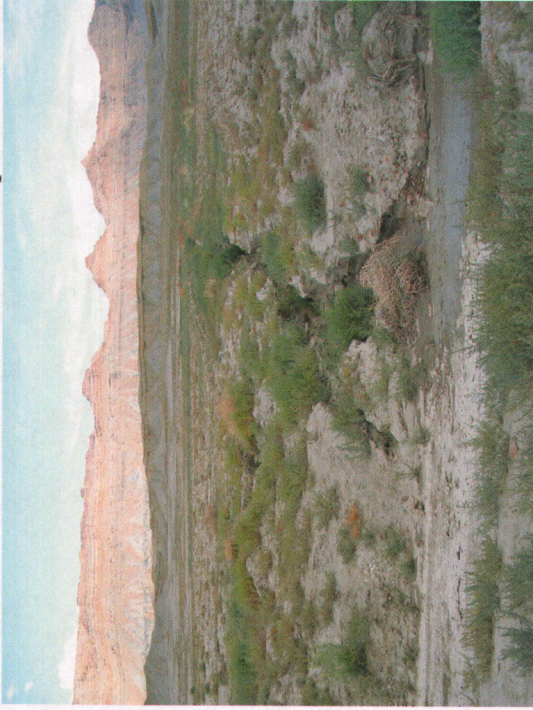
Photo 1. The second drainage crossing. I did not attempt to cross this drainage in my truck.

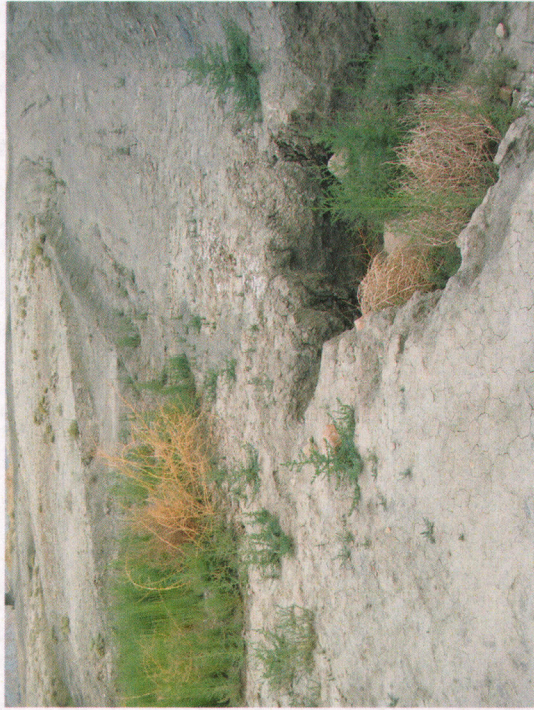
Photo 2. This is where the road crosses one of the minor drainages. I do not believe this road has been used recently.

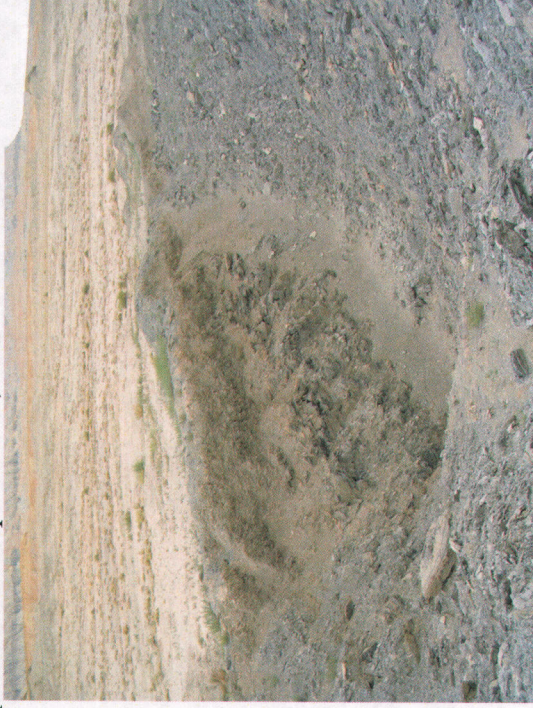
Photo 3. The mine pit. Note how the bottom is sloped on the far side; a person falling in to this pit could get out.

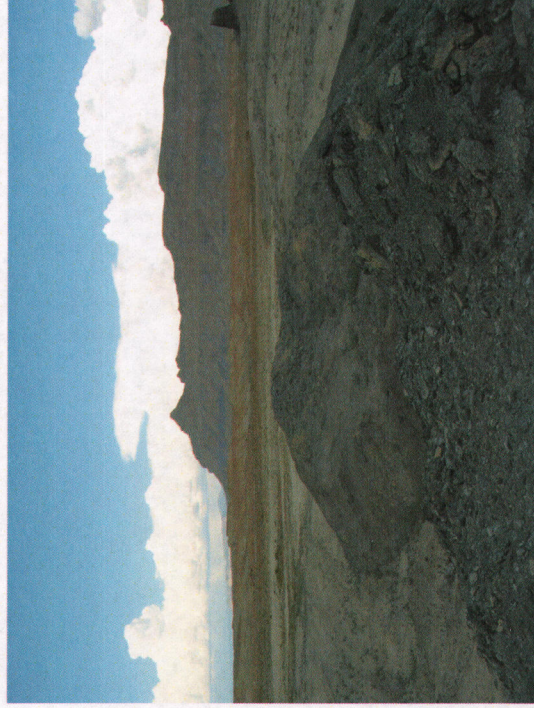
Photo 4. The pile of excavated material next to the pit.

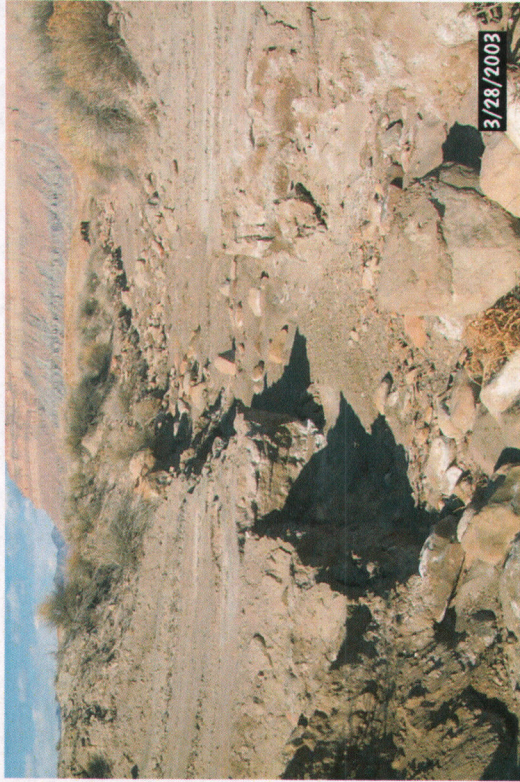
Photo 1. The first crossing.

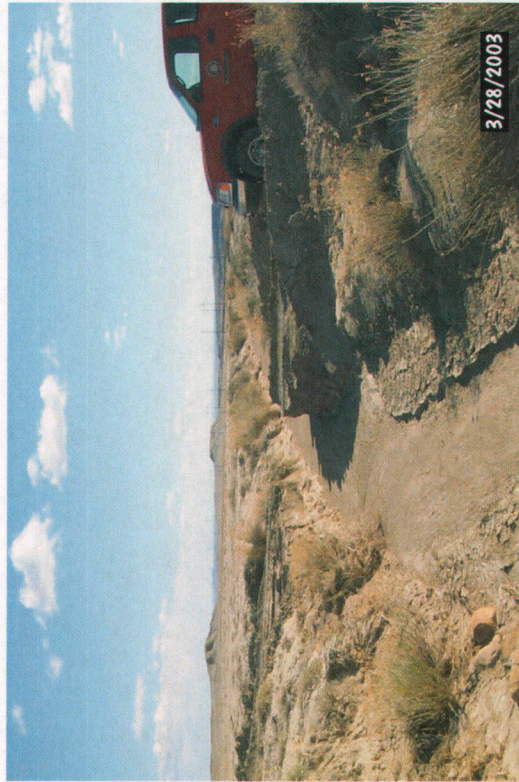
Photo 2. The second crossing. I was not able to drive this one.

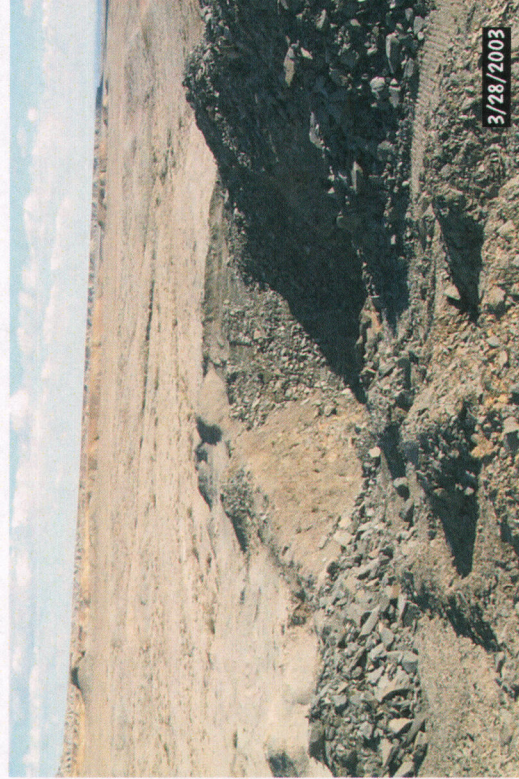
Photo 4. The excavation and some of the excavated material.

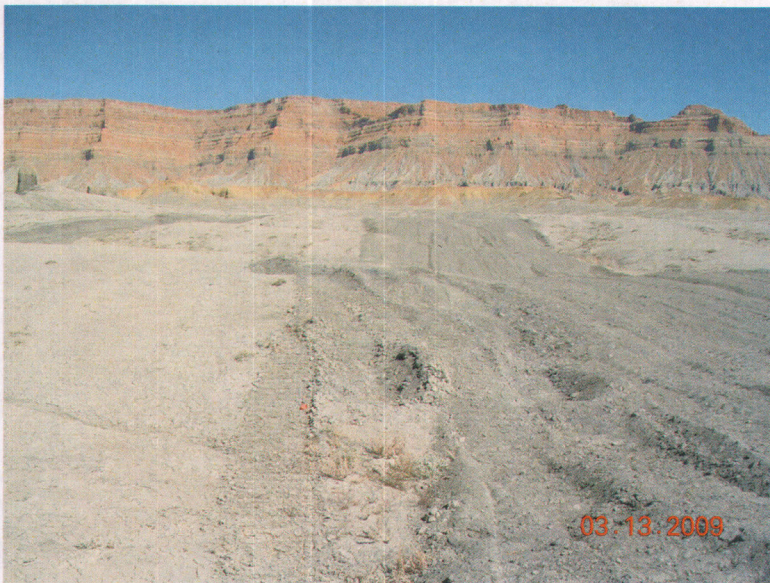
The trenches mentioned in the last inspection report have been regraded, and the mine site itself has also been regraded. I did not see any seed.

Photo 1. One of the regraded trenches.

It is probably too late in the year for seeding to be successful. The operator should seed the regraded areas next fall, and I suggest a seed mix that includes Castle Valley clover, mat saltbush, shadscale, and possibly bottlebrush squirreltail and/or Indian ricegrass. The area does not have a lot of vegetation, but there is some.

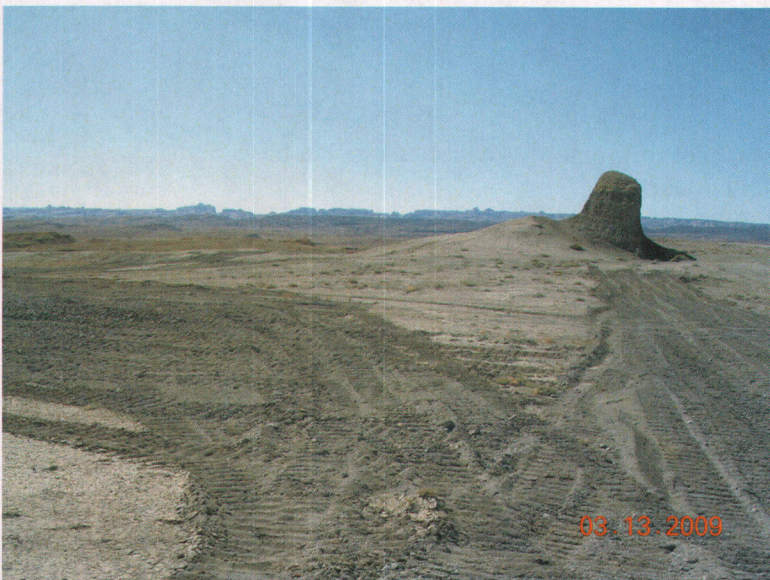
Photo 2. This is the regraded mine site.
